# TECHNICAL FEASIBILITY AND IMPLEMENTATION PLAN

Nature-based Restoration of the Buna River

***Secondary Channel Reconnection, Riverbank Stabilisation and Riparian Habitat  
Restoration***

**Project:** Restoration of Buna River Banks with Plant Engineering

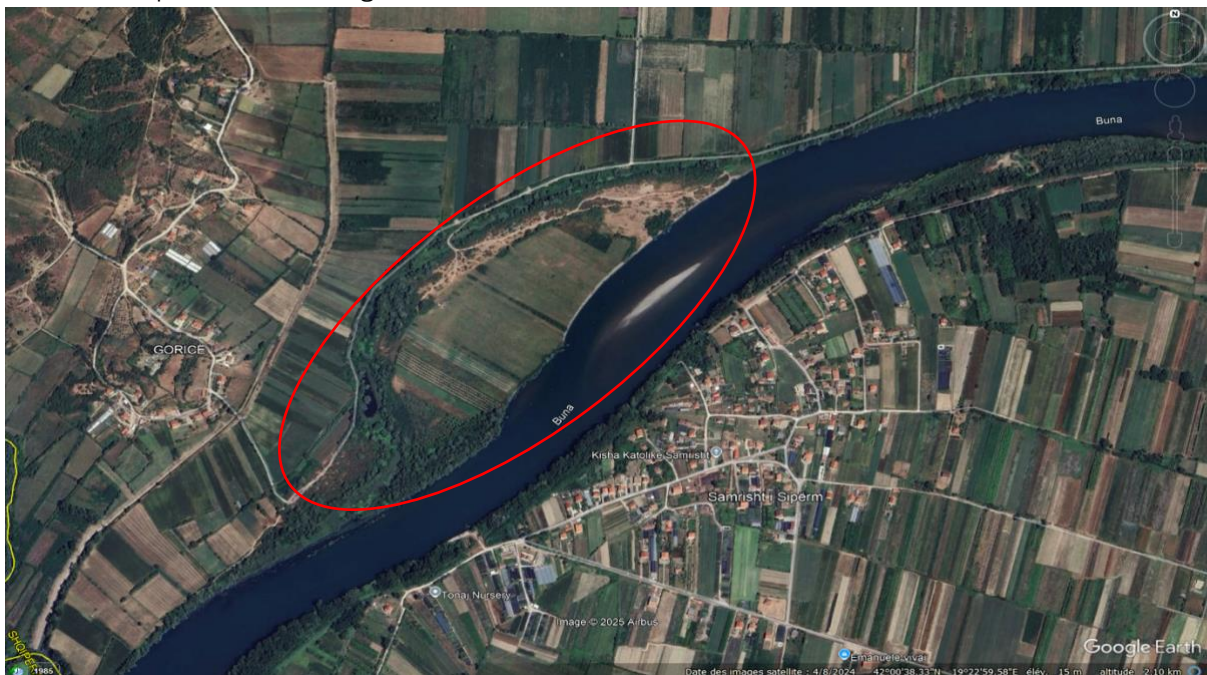
**Figure 1:** The project area selected for the intervention

EcoAlbania identified a priority 450 m reach on the right bank where erosion has become particularly visible. Immediately adjacent to this bank is a natural secondary branch whose upstream connection with the Buna has become increasingly restricted. Comparison of imagery from 2016 and 2024 and field observations undertaken during project preparation suggest that the side branch is less functionally connected than previously and that lateral river space at the site has become more constrained. The project has consequently developed the working hypothesis that a greater proportion of flow is now concentrated in the main channel and that this may be contributing to the erosion pressure affecting the right bank. The available information supports this as a credible restoration hypothesis, but it does not provide a detailed hydraulic model capable of quantifying the change in velocity, shear stress or discharge distribution. The intervention should therefore not claim that reopening the branch will produce a predetermined numerical reduction in hydraulic stress. Its rationale is instead hydromorphological: restoring an existing lateral flow path is expected to increase the space available to the river and may redistribute part of the flow during suitable water levels. The actual response will be observed during implementation and subsequent monitoring.

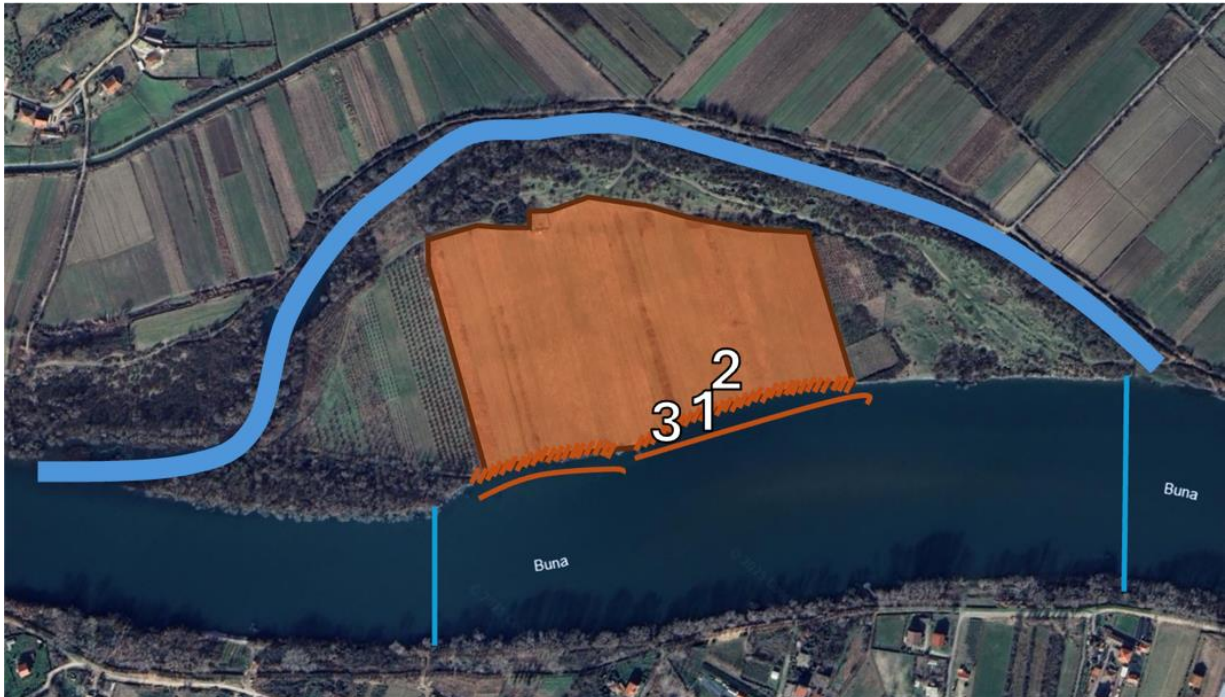
**Figure 2:** Morphology of the project intervention site

The main morphological feature relevant to the intervention is the relationship between the Buna main channel and the natural secondary branch. The branch remains visible and physically present but is restricted at its upstream connection by sediment and alluvial deposition. The available project material considers this inlet obstruction sufficiently localised for reconnection through relatively limited excavation rather than reconstruction of the full channel.

The loss of connectivity matters because side channels provide additional space for the river to distribute water and sediment. Historical imagery indicates that the site had greater lateral openness previously.

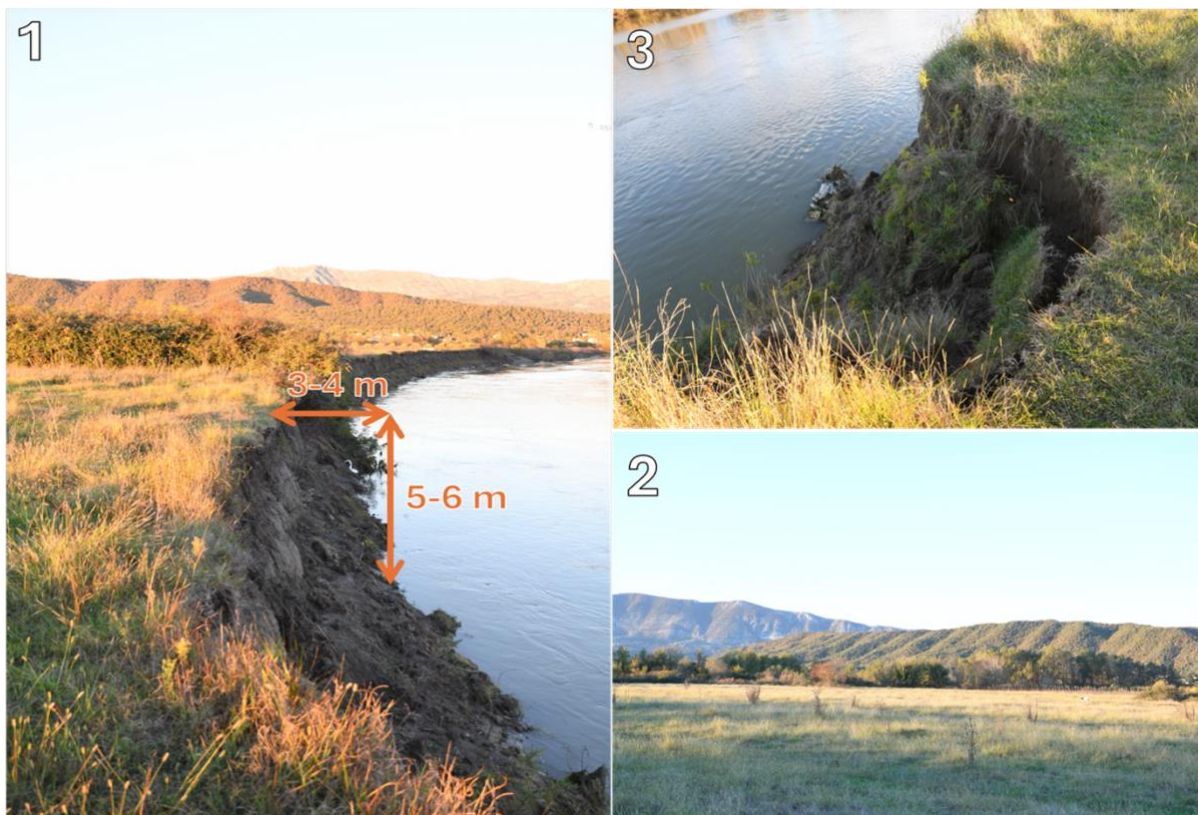
**Figure 3:** Illustration pictures of riverbank and river terrace at the proposed intervention site

The present working diagnosis is that the reduction of this lateral flow path has contributed to concentration of hydraulic action in the main channel and therefore to increased pressure on the right bank. The project presentation and the longer Technical Plan both rely on this interpretation. The right bank has consequently experienced active erosion. Earlier field observations describe the bank as broadly 5–6 m high in relevant sections.

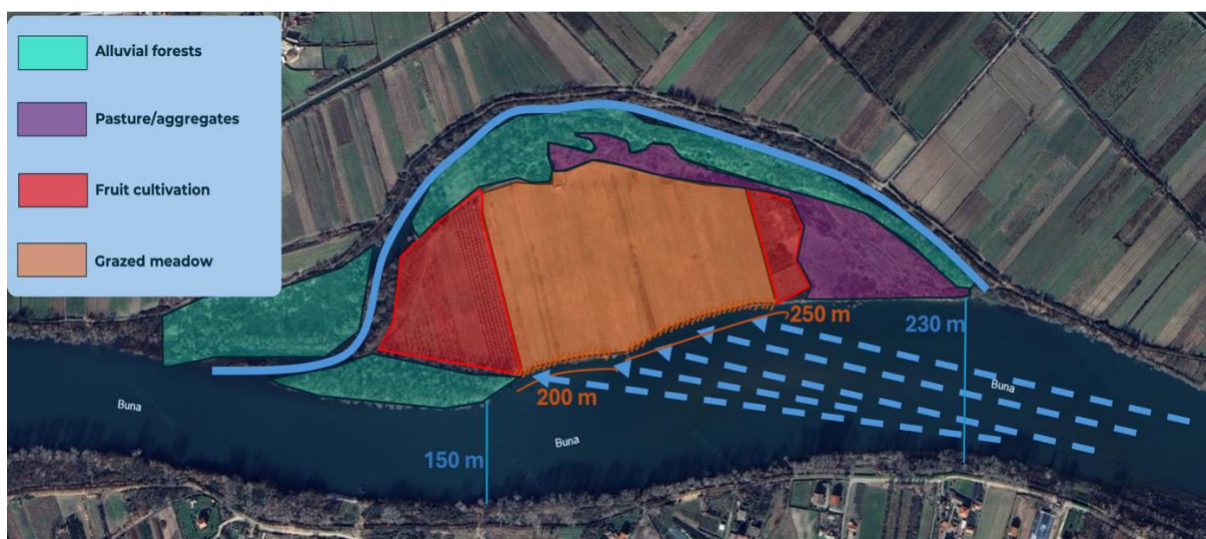
**Figure 4:** State of landuse and vegetation cover at the site

The same differentiated approach should apply to planting. The objective is not to achieve a uniform density across the entire project reach. Lower wet areas requiring rapid root reinforcement should receive more intensive living material. Higher areas can support a more diverse and less dense riparian structure. Areas with strong natural regeneration can be protected rather than replanted.

This spatial strategy is the principal mechanism through which the project reconciles erosion management, biodiversity conservation and minimum intervention. It also means that the final quantities cannot be calculated reliably simply by multiplying the earlier 200 m design by 1.25.

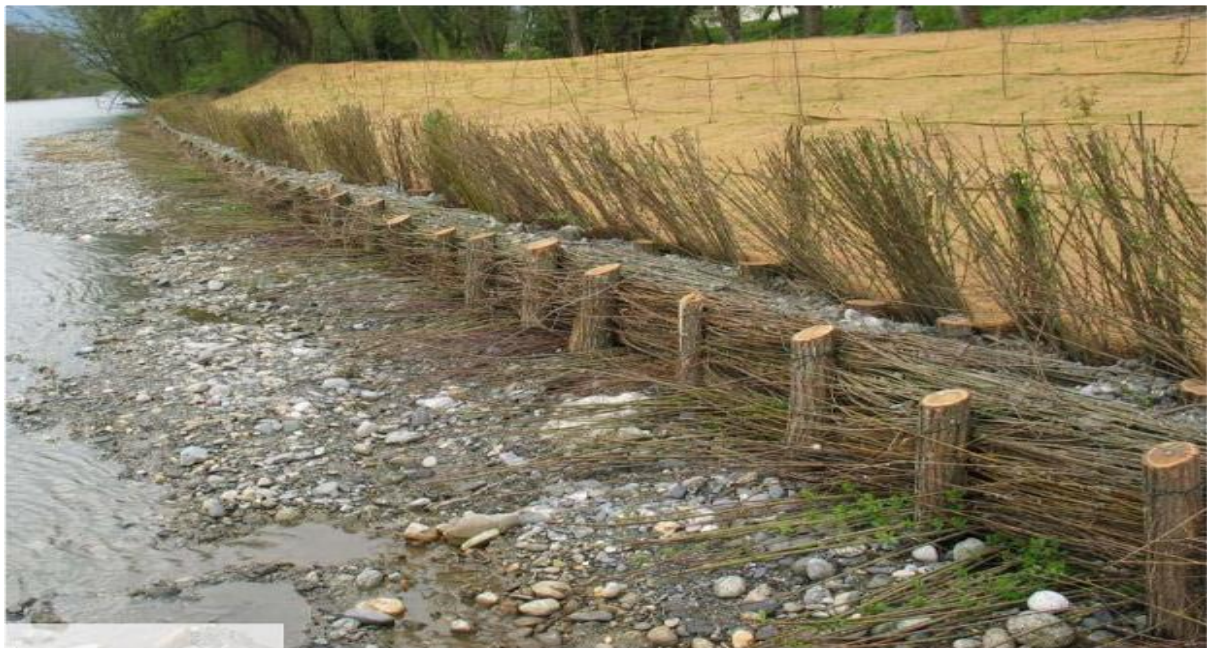
**Figure 7:** Demonstration of the Willow fascines concept that could potentially be implemented on site

Willow fascines will form one of the principal lower-bank bioengineering measures.

They should be prepared from healthy, flexible, locally derived willow material collected during a suitable dormant period and installed promptly to avoid drying. The bundles should remain in close contact with moist soil and should be firmly secured with appropriate stakes or posts.
